**REPORT ON THE DENNETT HOUSE  
TRADITIONALLY CALLED “THE BEEHIVE”  
73 PROSPECT STREET  
PORTSMOUTH, NEW HAMPSHIRE  
NOVEMBER 26, 2017**

**JAMES L. GARVIN**  
FARRINGTON HOUSE

This report is based on an inspection of the Dennett House, traditionally called “the Beehive,” on November 13, 2017. The purpose of the inspection was to observe and identify the character-defining features of the dwelling. Of special interest were the longstanding beliefs that the house dates from 1680 (or other attributed dates in the late seventeenth century), that it is one of the two oldest surviving buildings on Christian Shore and therefore one of the oldest buildings in Portsmouth, and that its walls are constructed of “solid square timbers.” The latter assertion would suggest that the building began its existence as a log-walled structure of a type first documented in Portsmouth in a meeting house built near the South Mill Dam in 1659.

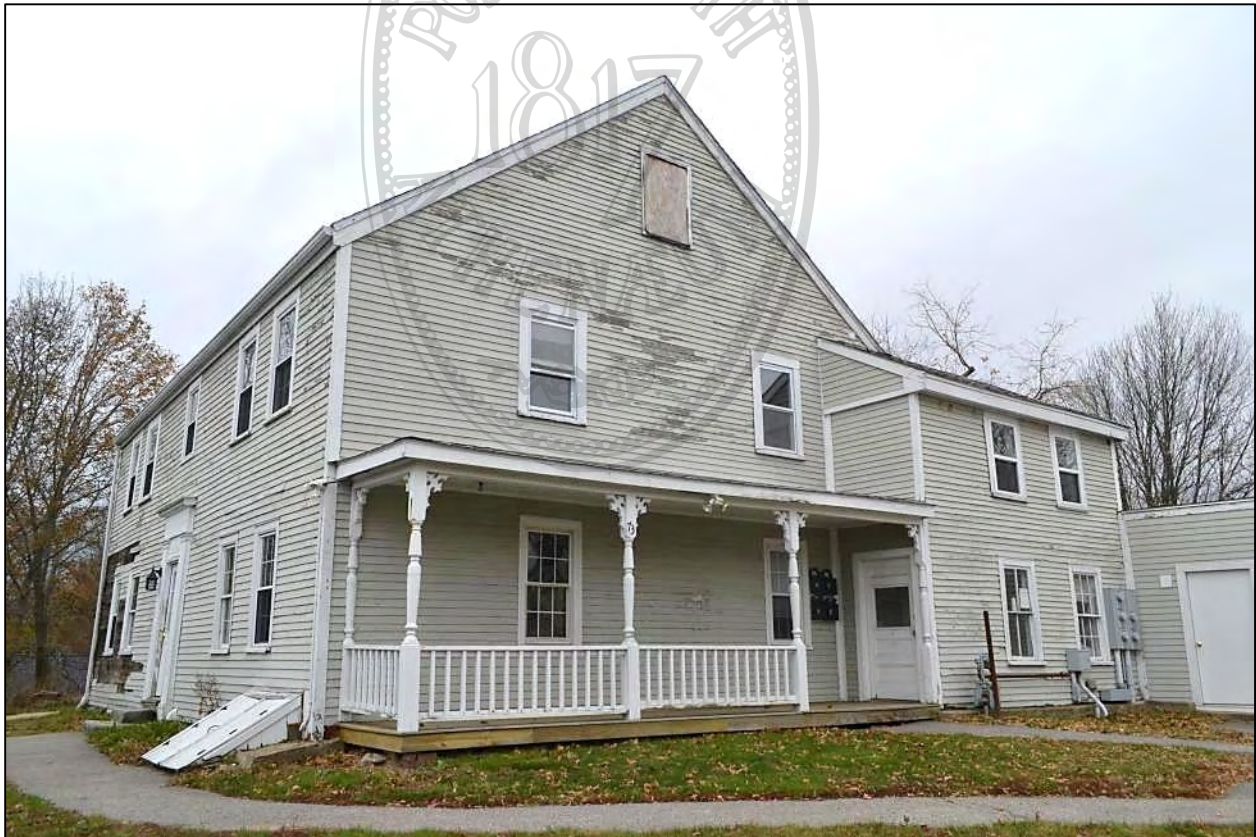
*Dennett “Beehive”, South (Front) and East (Side) Elevations*

As seen on the cover of this report, the house is a large framed dwelling, formerly having a central brick chimney that projected above the ridge. The building is clad with clapboards and marked by an open porch on its eastern elevation, a two-story wing (formerly with its own chimney) that envelops the northeastern corner of the main dwelling, and a shed-roofed addition that extends along the north wall of the wing and projects beyond the wing's eastern wall. To the east of the house stands a detached and much altered building, now adapted for apartments but once apparently serving as a stable and carriage house for the dwelling.

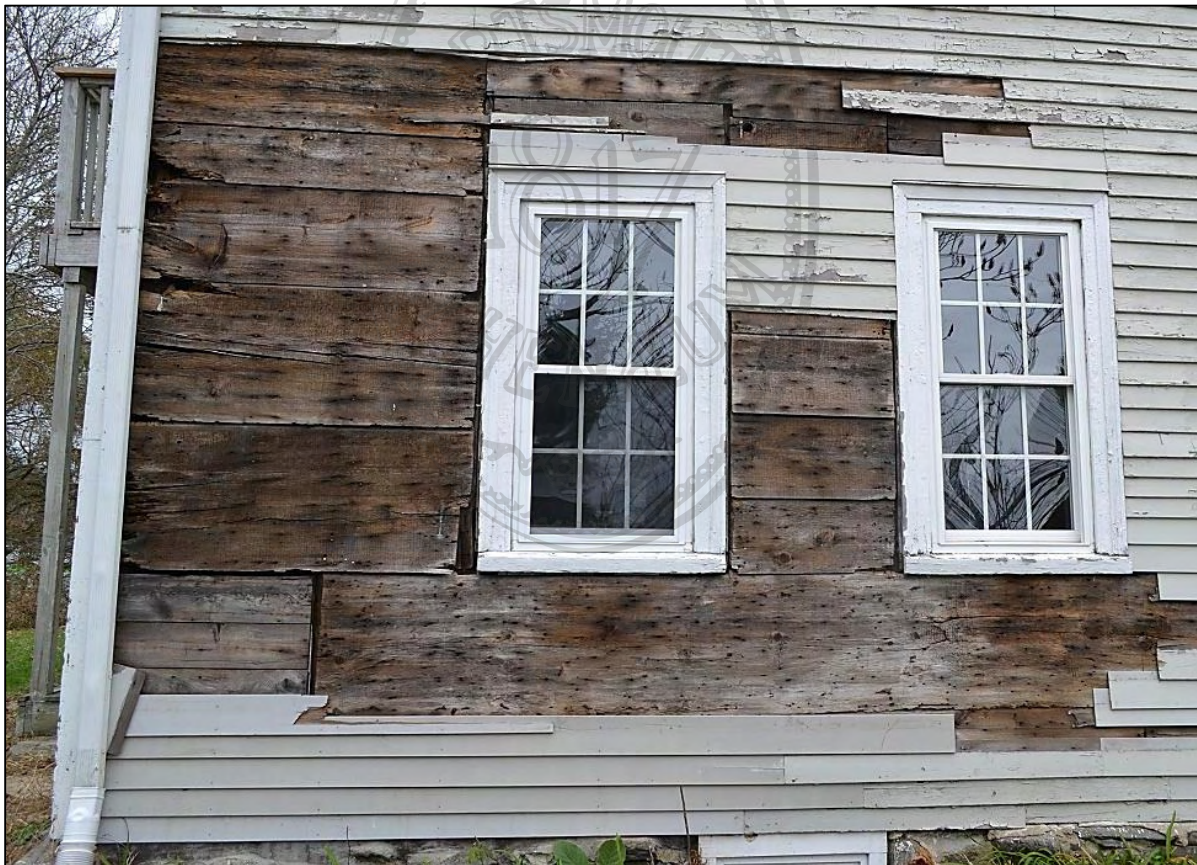
*Dennett House, southwestern corner, camera facing north. The exposed sheathing bears a combination of forged and cut nails, with the latter predominating. Cuts in the sheathing above the windows indicate that the windows were lowered or reduced in size at some time.*

As seen in the photograph above, the window sashes of the house are new. A photograph in the collections of Historic New England, probably dating from circa 1935, shows that the house then had six-over-six sashes, which were common in the mid-1800s and probably relate stylistically to the window casings now seen on the first story. These casings indicate a remodeling during the mid-nineteenth century. As seen below, they incorporate backband moldings of a characteristic Greek Revival pattern.

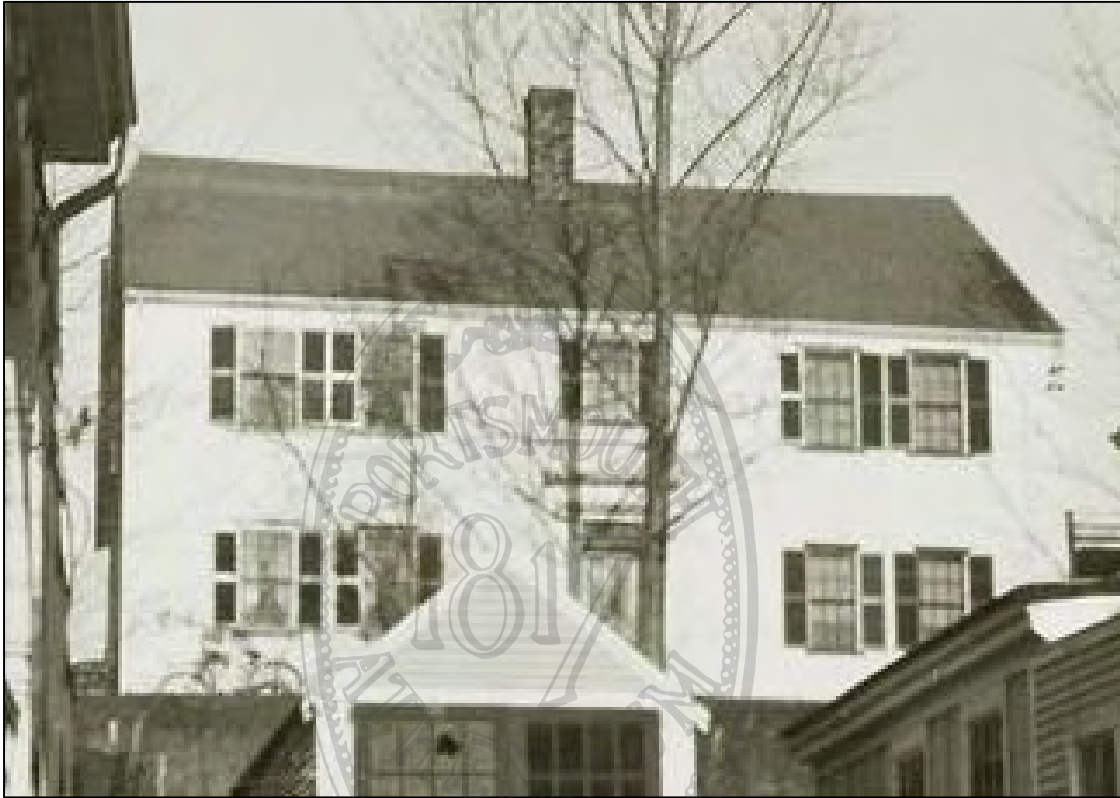
*Detail, photograph, Dennett "Beehive," circa 1935. Historic New England Collections:*  
<https://www.historicnewengland.org/explore/collections-access/gusn/225576/>

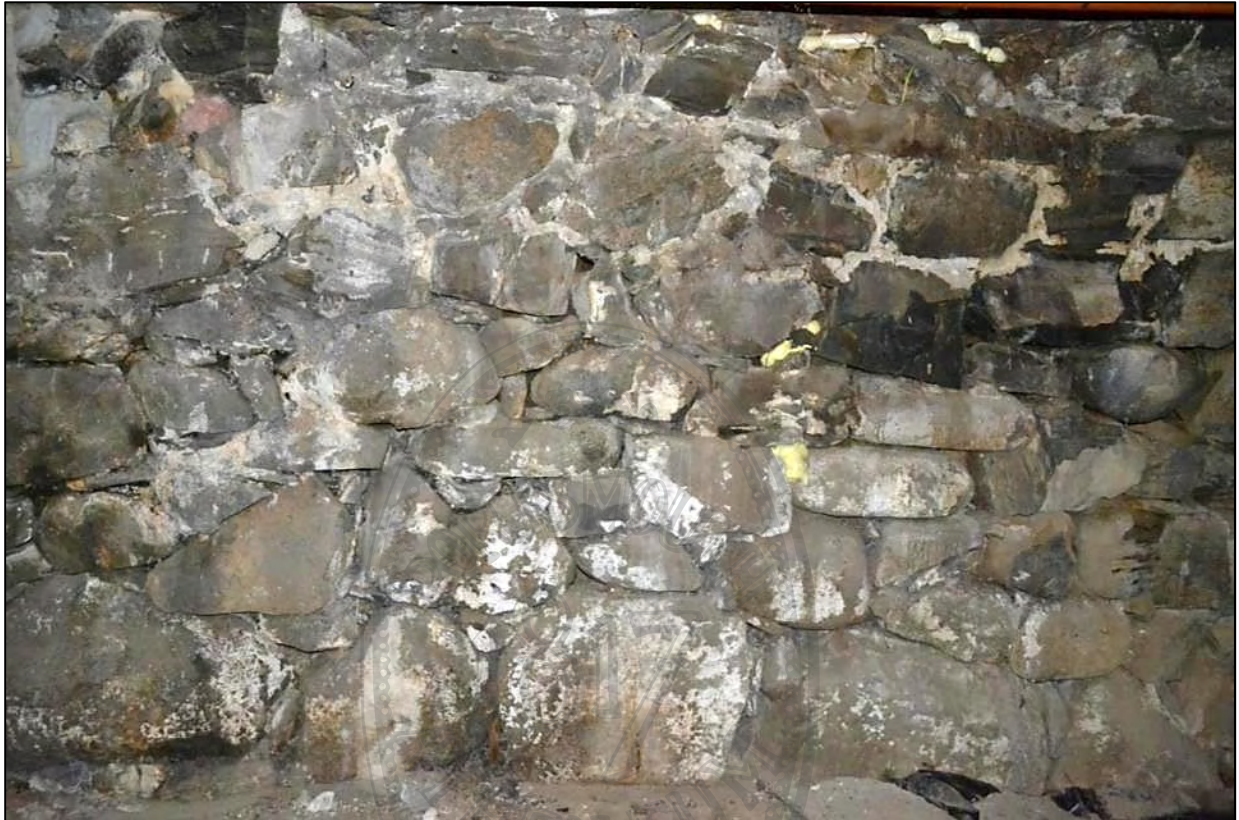
The cellar walls are constructed of a combination of glacially rounded fieldstones and fractured stone, well pointed with lime-sand mortar. The fractured stone is a metamorphic type that is frequently seen in Portsmouth foundations. Its apparently unweathered appearance suggests that it was extracted by quarrying or blasting with black powder, but this appearance may result from its manner of weathering. Geological studies of the Portsmouth area identify this stone as deriving from the “Kittery formation.” The Kittery formation underlies all of northern Portsmouth from Little Harbor to the Newington town line, extending into Kittery as the bed of the Piscataqua River and often lying exposed along the shores of the river.<sup>2</sup> Like adjacent geological formations, the Kittery formation is composed of metamorphic rocks that derive from

*Southern wall of basement, showing natural fieldstones near the base and angular stone near the top. The wall was originally pointed with lime mortar and retains remnants of lime wash (whitewash). The house lacks split granite underpinning at grade level; the mortared angular stone extends above grade to support the house sills.*

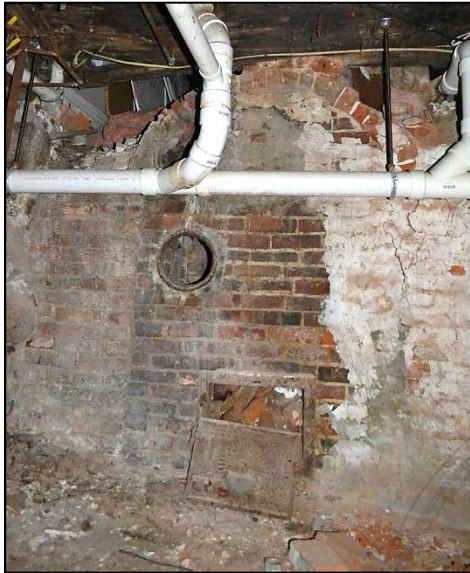
Evidence in the basement of the original wing indicates that the former chimney of the wing, seen in the Sarah Haven Foster watercolor, served a summer kitchen. As seen from the main cellar, the chimney foundation displays a brick vault that was probably open when first built, but was later partially filled by a furnace or boiler chimney when the house was first provided with central heating. This chimney was provided with a cleanout door that was fashioned from a cast iron door from a former brick oven, probably taken from the room on the first story. The style of

*Left: South face of summer kitchen chimney base, showing brick vault (top) and re-used oven door (bottom).*

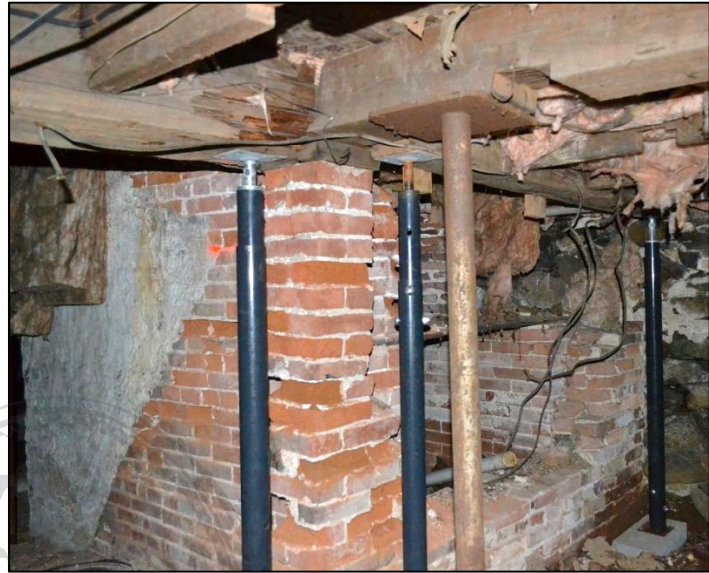
*Right: East (side) and north faces of summer kitchen chimney base, showing evidence of former Stairs from the room above.*

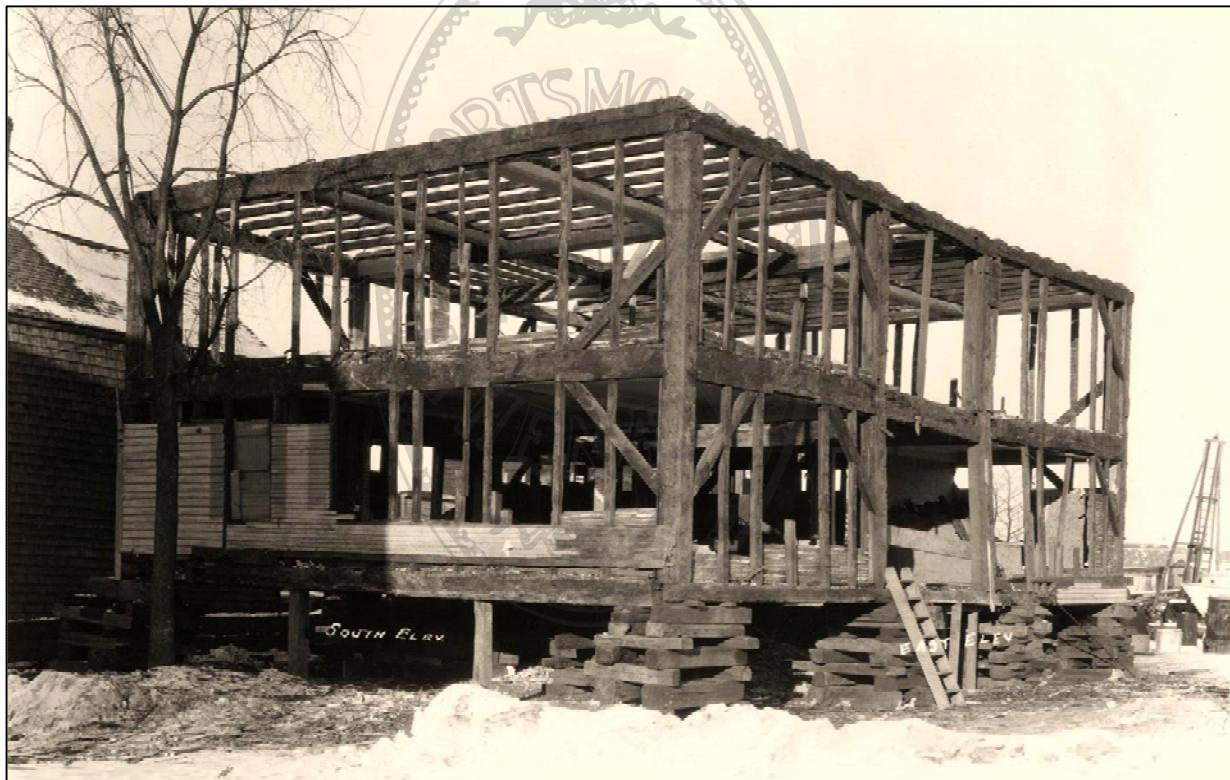
*Lieutenant-Governor John Wentworth House (after 1695), shown in 1926 after being moved from its original site and partially disassembled for the sale of its interiors to the Metropolitan Museum of Art, New York. Metropolitan Museum of Art, Sage Fund, 1926. Neg. No. SF 294.*

The earliest documented example of a two-room-deep central-chimney Portsmouth house with two-post bents is the Lieutenant-Governor John Wentworth House, which was built between 1695 and 1701 and stood until 1925 on the southern shore of Puddle Dock in Portsmouth's South End. As seen in the photograph above, this house had a frame that matched that of the Dennett House in having four framing bents with two posts (front and rear) in each bent. The Wentworth House also matched the Dennett House in having two equally-sized summer beams spanning the intervals between end wall bents and chimney bents, as seen with greatest clarity in the attic framing, silhouetted against the sky in this photograph.

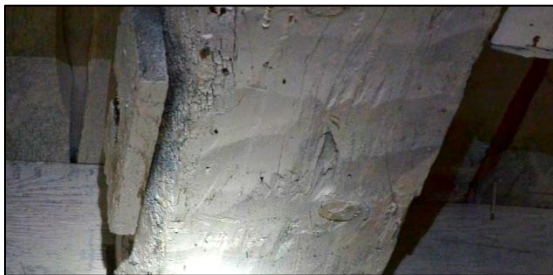
By contrast, the principal framing members of the Dennett House are expertly hewn, but not planed or chamfered. This fact indicates that these members were intended to be covered with applied casings fashioned from planed one-inch boards, a practice that remained universal during the remainder of the eighteenth century. It is possible to see the "shadow" or change of coloration in the summer beams on the western side of the house even though the casings here have been removed and the hewn surface of the beams exposed to view. The first known

*Left: Summer beam in southeast first story room of Dennett House, showing hewn surface and lack of chamfering at lower edges.*

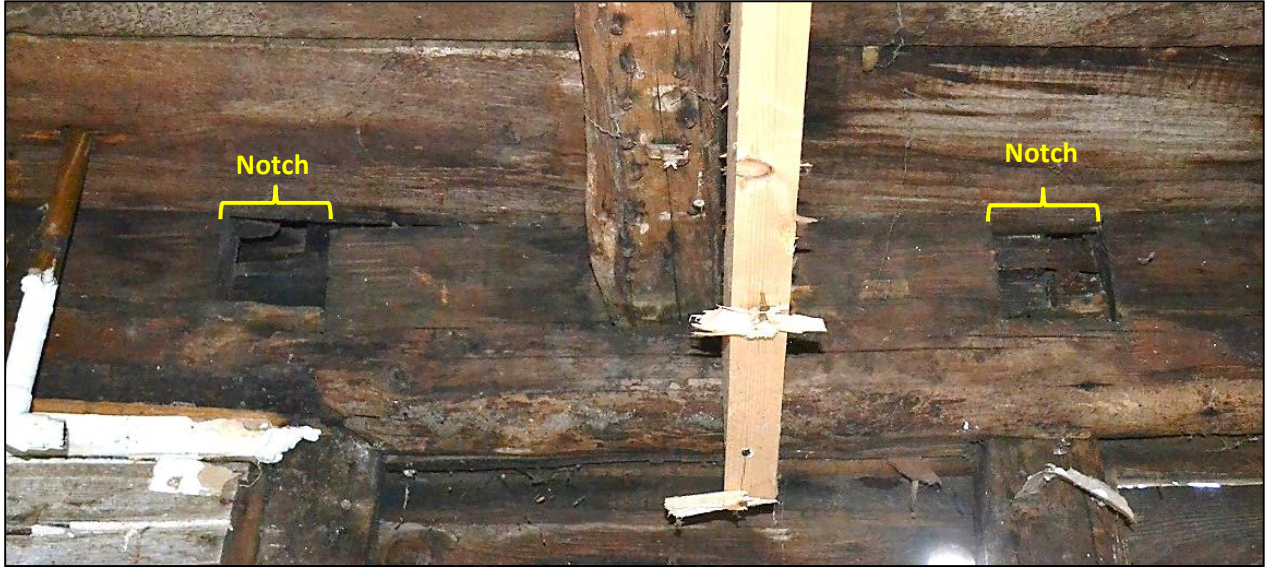
*Front girt of Dennett House, southwest first floor room, looking south and showing an original second floor joist (center) and two empty notches for joists (left and right). These details illustrate the use of butt-cogged joist connections and suggest a construction date after 1700.*

In general, the ceiling framing of the Dennett House is composed of pine common joists, as seen in the photograph above, that measure about 4 inches in width and 4½ inches in height. The bridging joists or summer beams that receive these common joists measure about eleven inches in width by 7½ inches in height.

As may be seen by the remnants of wrought nails in the bottom of the joist shown above, the lath that held the original ceiling plaster in the southwest first floor room was nailed directly to the joists, creating a ceiling plane that was higher than the projecting bottoms of the summer beams. As noted, the summer beams are roughly hewn and show evidence of originally having been covered with planed board casings that provided a finished appearance below the plaster of the ceilings. Ceiling lath, now missing, was riven from pine and fastened to joists with wrought nails.

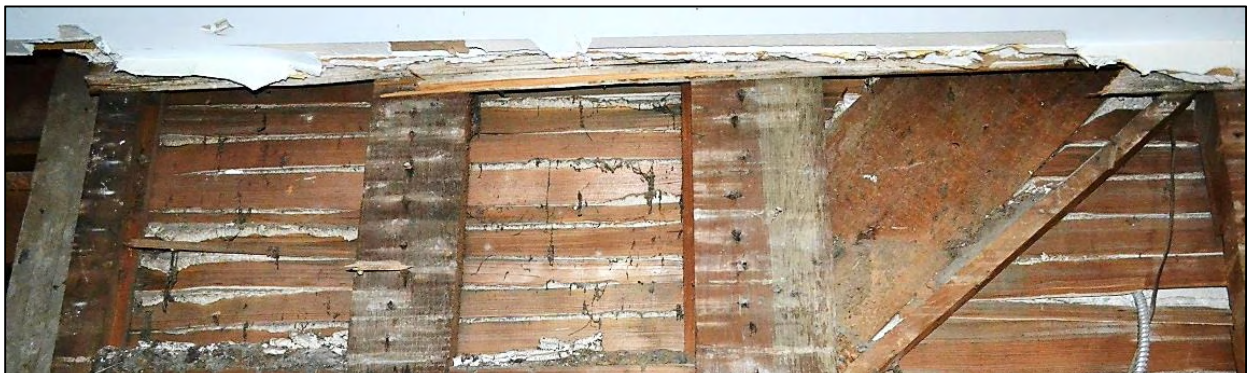
*Section of riven (split) pine lath, seen from the southwest front room looking toward the staircase wall and showing the back of the lath strips and the protruding plaster "keys."*

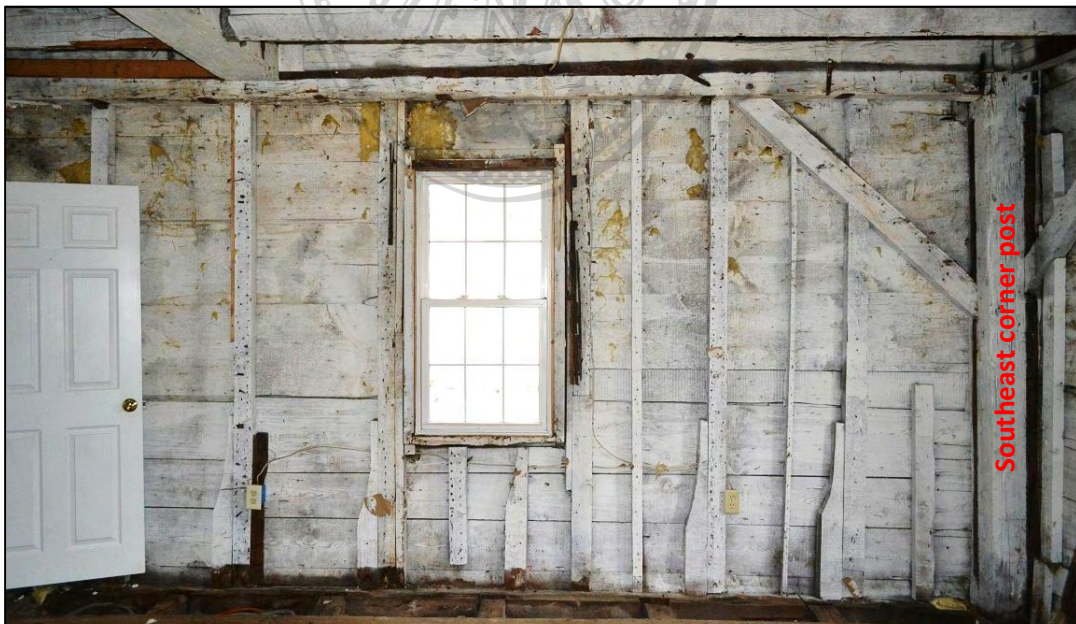
The wall framing of the house is standard, as seen in the detail of the southern wall of the southeast room on page 12 and in the photograph of the eastern wall of that room, below.

*Eastern wall, southeast room. Principal studs may have been sistered during sill repairs.*

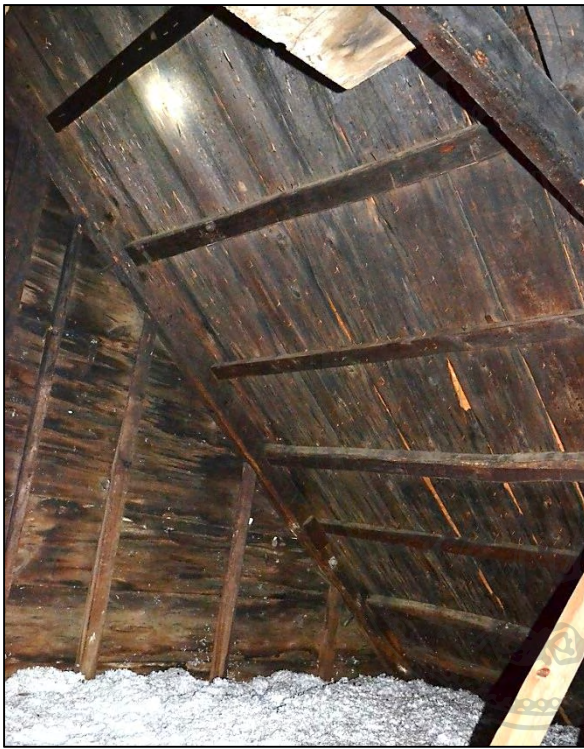
As seen below, the roof frame was damaged and charred by a chimney fire that occurred after the original central fireplace chimney was replaced by two stove chimneys that converge in the attic to form a single stack. The charring makes it difficult to study the roof in close detail. This form of chimney, frequently employed in Portsmouth when central fireplace chimneys were replaced by stove chimneys, is colloquially called a “pair of pants” chimney and is difficult to clean, increasing the threat of chimney fires.

*Left: Roof frame, camera facing southeast.*

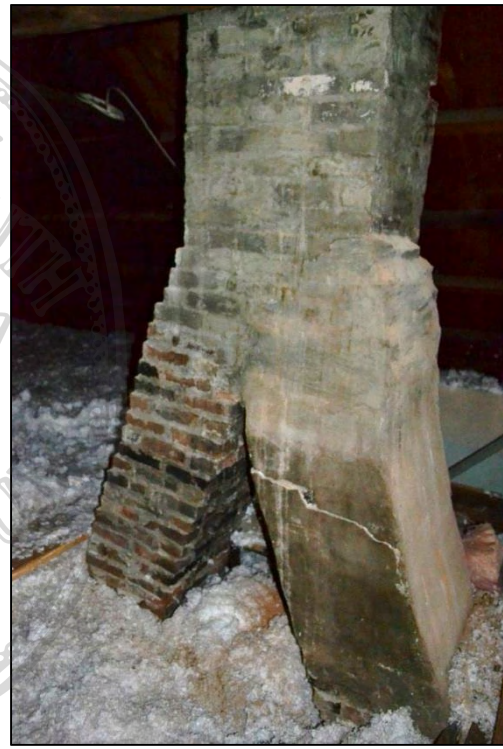
*Right: Chimney, camera facing southeast.*

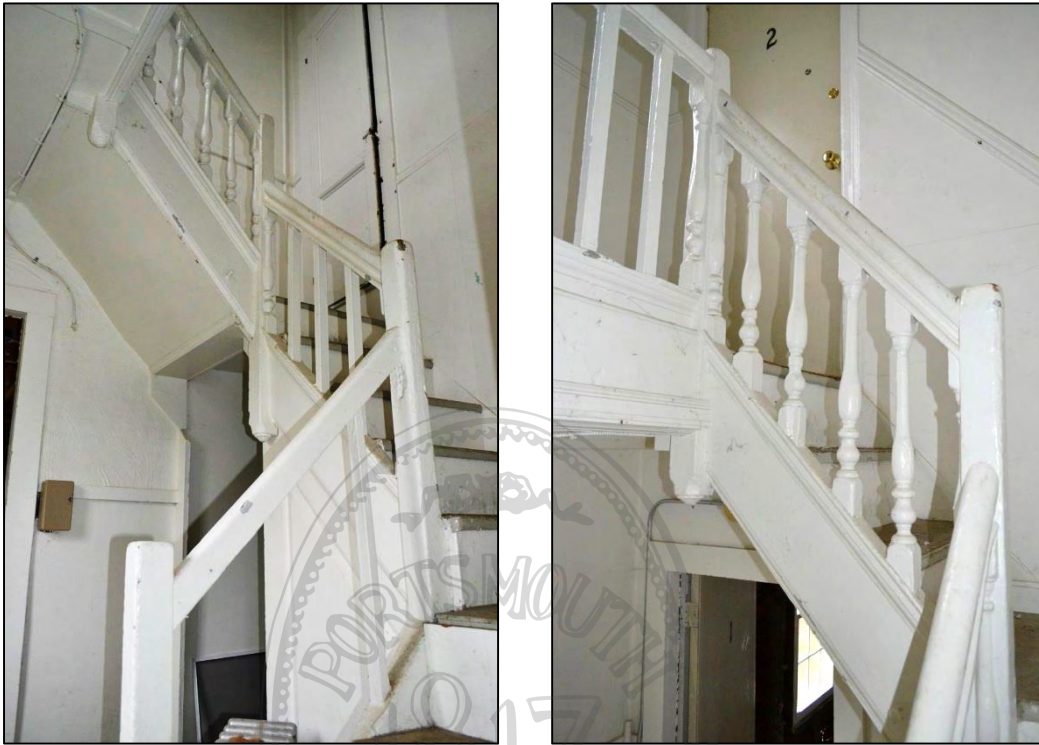
As seen above, the staircase is a closed-stringer type, in which the balusters are supported on the upper surface of a slanted stringer rather than on the level treads of the staircase. This detail is generally regarded as characteristic of the “First Period”—the seventeenth and early eighteenth centuries. Relatively few closed stringer staircases have been recorded in Portsmouth, and the more opulent houses from as early a time as the Macphedris-Warner House (1716) have grander staircases with open stringers.

As noted earlier, only a sampling of original balusters remain in the Dennett House staircase. In the staircase runs that are more visible to the eye, the turned balusters were replaced at some point—perhaps the mid-1800s—by the then fashionable square sticks seen in the photographs.

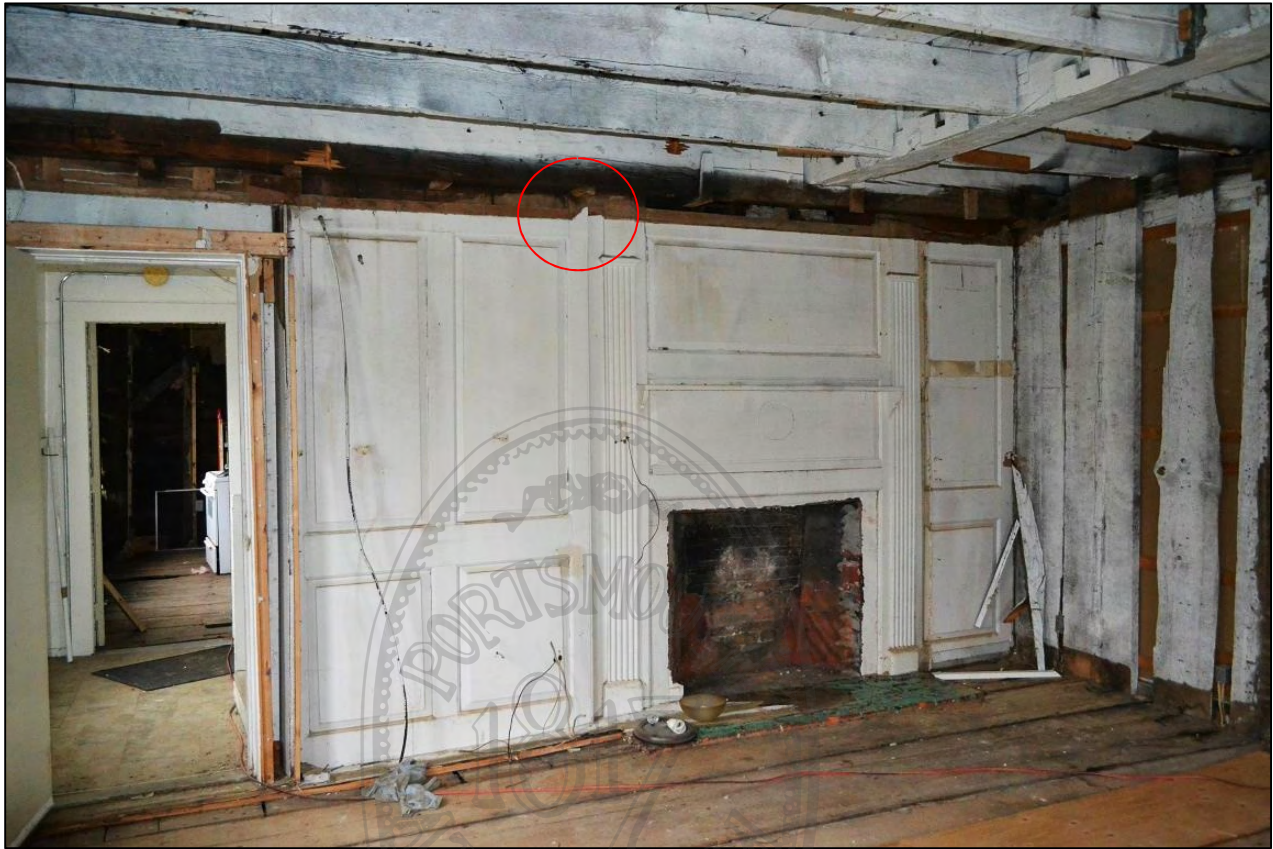
*Southeast first-story room (parlor), Dennett House. The panel arrangement and fluted pilasters are common features of Portsmouth houses from the 1750s, but comparable features appeared as early as circa 1730 in the George Jaffrey, Jr., House on Linden Street, off Daniel Street.*

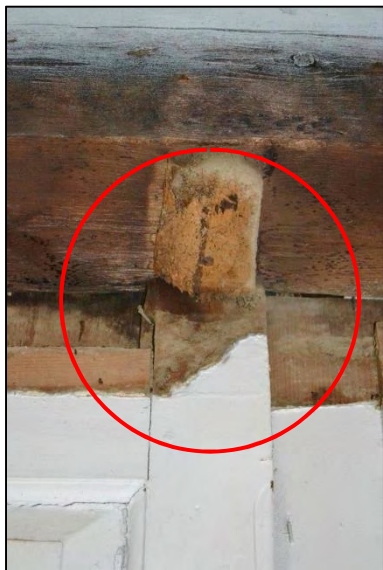
As seen in the detail photograph at the left, enlarging the circled area in the room photograph above, a paint outline near the ceiling level shows that the chimney wall originally had a molded cornice. The chimney girt above this molding is furred out with wooden shims. This indicates that the molding profile is that of a bed molding and that a full cornice, with a crown molding, enveloped the girt above. An enlarged section of such a cornice is shown on the following page.
